EXPERIMENTAL ASSESSMENT OF THE OUT-OF-PLANE PERFORMANCE OF MASONRY BUILDINGS THROUGH SHAKING TABLE TESTS

Candeias, P.X, Campos Costa, A., Mendes, N., Costa, A.A., Lourenço, P.B.

Keywords: Clay brick masonry, Stone masonry, Shaking table tests, Seismic performance

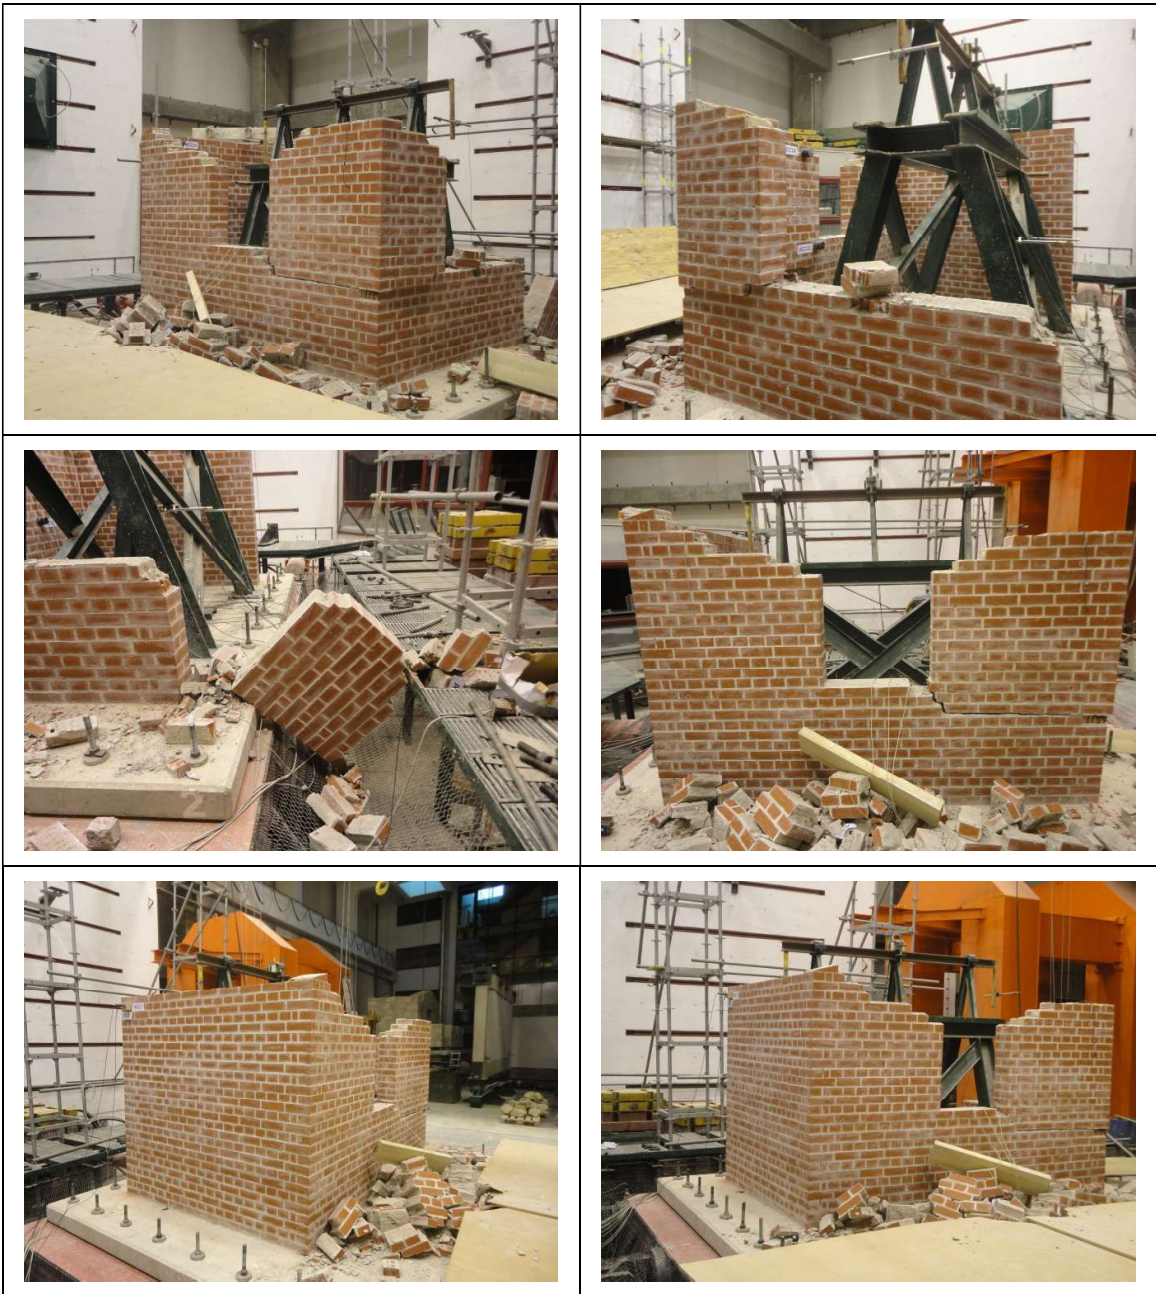
Figure 15 – Final damage state on the Brick House

The Brick House mock-up was extensively damaged in TEST08 (1.27g) with the partial collapse of the gable top and North lateral wall, see Figure 15. The collapse sequence can be described in the following way: i) the northern part of the gable top fell in the out-of-plane direction (towards East); ii) at the same time the Northeast pier rocked without falling, and rotated around the vertical axis, while the Northwest pier was only rocking; iii) as a consequence, the lintel over the window on the North lateral wall fell vertically due to the lack of support provided by the Northwest pier; iv) ultimately, the Northwest pier rotated around the base towards West and subsequently fell out of the shake table; v) the southern part of the gable top fell in the out-of-plane direction (towards East).

The presence of a window opening in the North wall and a blind wall in the South side introduced an asymmetric dynamic behaviour that precluded a clear out-of-plane collapse mechanism of the East façade. In fact, the damages are particularly concentrated on the North side of the mock-up while the South wall remained almost intact until the end. As a consequence, two types of collapse emerged one the in-plane of the North wall and the other the out-of-plane of the gable top initially triggered by the former.

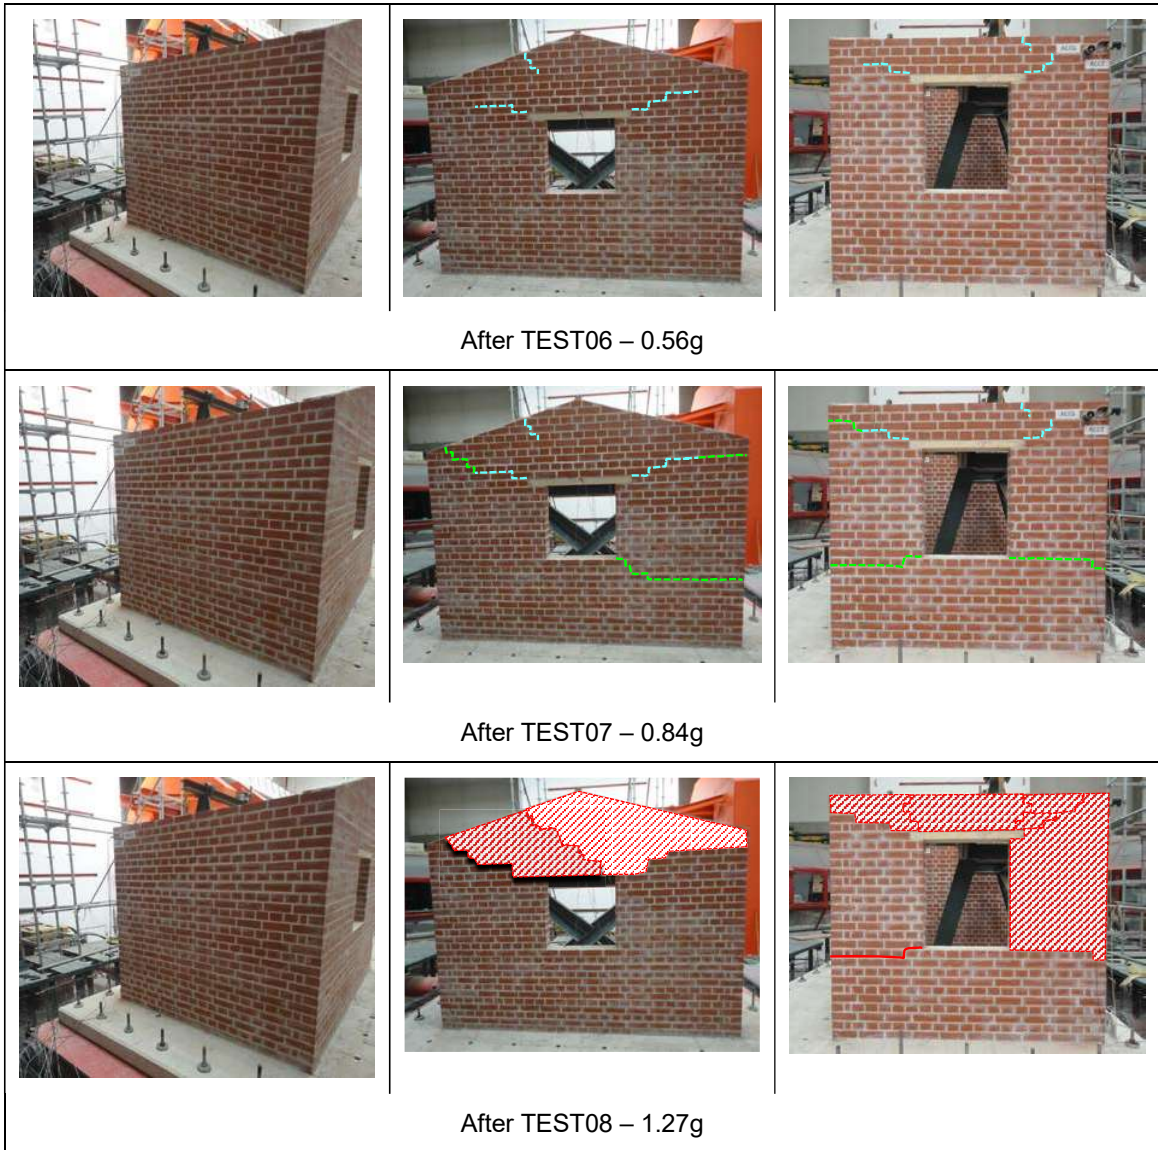
Figure 16 – Damage progression of the Brick House (left to right: South sidewall, East façade, North sidewall)

The collapse mechanism started to form at TEST05, with cracks less than 1mm width near the corners of the windows. In TEST06 the previous cracks extended in length and new ones appeared, again with less than 1mm width. In TEST07 the cracks continued to extend horizontally in the direction of the corners of the walls, with widths higher than 1mm. Figure 16 illustrates the evolution of the collapse mechanism.

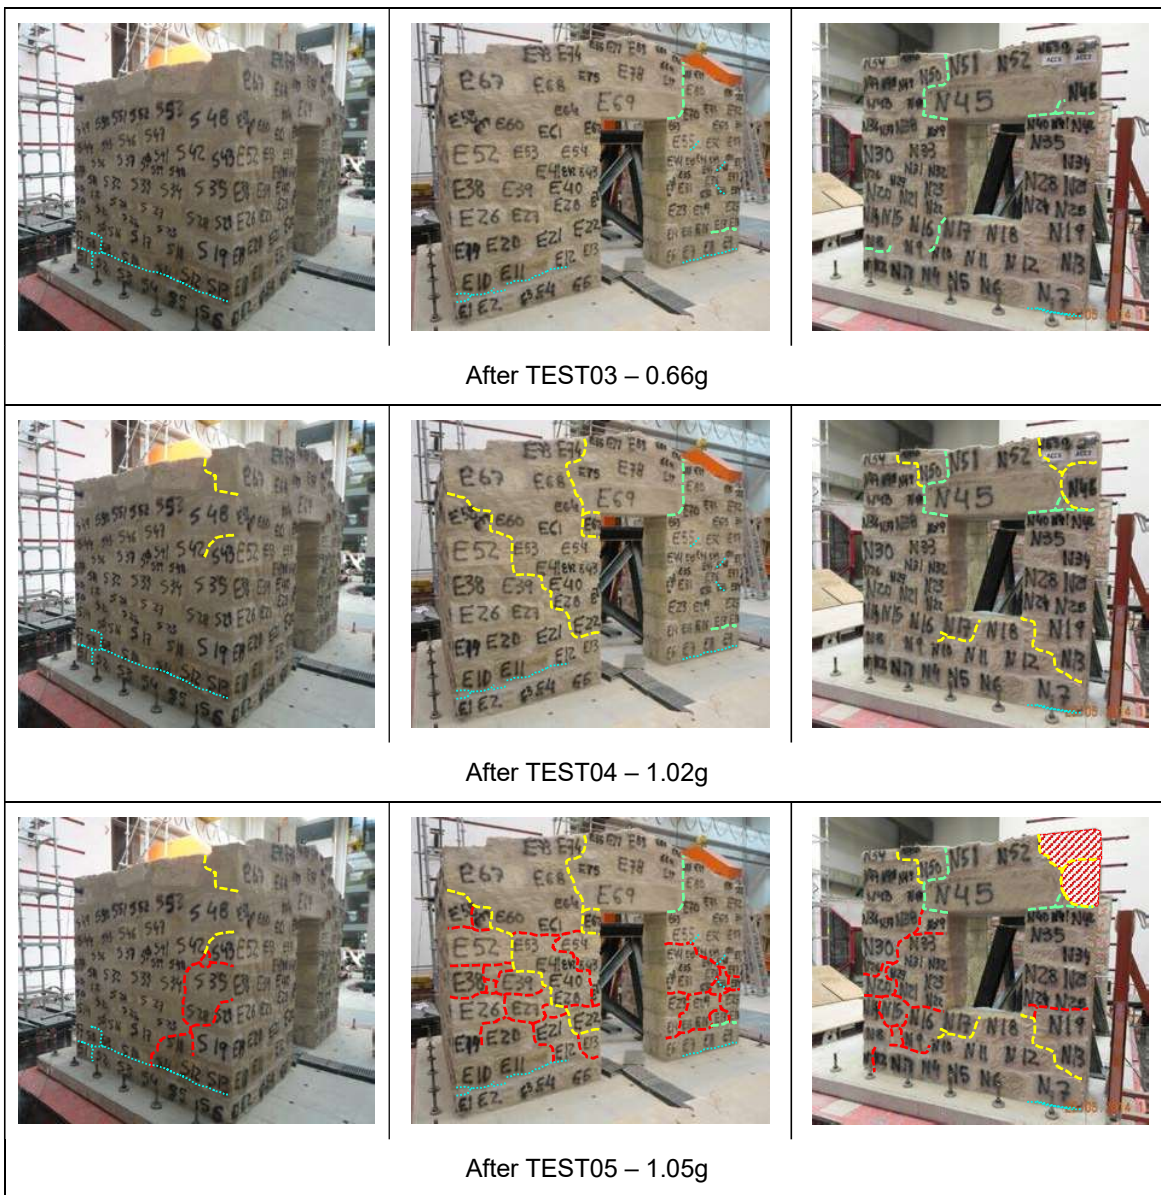
Figure 17 – Damage progression of the Stone House (left to right: South sidewall, East façade, North sidewall)

Initial damage state observed in the Stone House mock-up before the seismic testing plan started. A horizontal thin crack, less than 1mm in width, was visible on the South wall, right above the first layer of stones, that continues into the East wall up to the door; on the other side of the door three stones have also minor thin cracks. In the Northwest corner there is a small horizontal thin crack at the base, underneath one stone. Figure 17 illustrates the damage progression in the Stone House mock-up marked over the initial pictures (including the initial damage in cyan colour). After TEST03 there was some damage, with cracks propagating from the corners of the door and window and a horizontal one near the base of the Northeast corner. In TEST04 the damage progressed in the East façade, with large diagonal cracks propagating from the top South corner of the wall down to the mid height near the door, and also on the North side wall with the propagation of the existing cracks and the appearance of two new ones in the top Northwest corner and in the window lower West corner. In the last test, TEST05 (1.05g), the East façade developed an extensive crack pattern around the stones,

that propagated around the corner to the North side wall, additional cracks developed in the South side wall and in the Northwest pier, and the two stones on the top Northwest corner detached and fell.

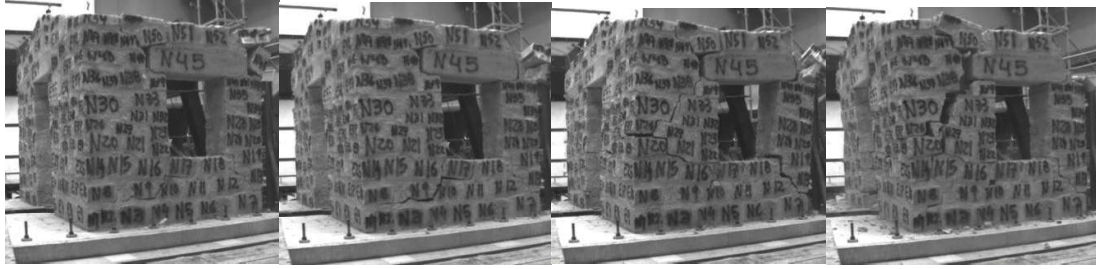
Figure 18 – Still images taken from the Stone House mock-up last test video recording (from left to right: a, b, c, d)

The damage sequence (Figure 18) in the last test was the following: i) the two stones on the top Northwest corner detached and fell out of the shake table due to the impulses that the large lintel stone over the window imposed on them (Figure 18a); ii) the Northwest pier rocked in-plan around diagonal cracks that formed from the lower corner of the window; iii) the Northeast corner rocked in the East-West direction, first as a single element, with a crack underneath it propagating from the lower corner of the window (Figure 18b), and later on split into two parts by diagonal cracks, one of them stabilized by the weight of the large lintel stone over the window and the other slightly rotated around the vertical axis (Figure 18c); iv) the South wall behaved like a large unique block delimited by the horizontal crack described in the initial damage and by cracks around the interlocking stones on the Southeast corner; v) the East façade rocked out-of-plane around large cracks that formed on both sides of the door, approximately horizontal near the base at mid-height on the North side (Figure 18d) and diagonal on the other side, propagating from the Southeast corner interlocking crack down to the mid height near the door; vi) the central part of the gable top delimited by the diagonal cracks formed on both sides of the lintel stone above the door rocked out-of-plane.

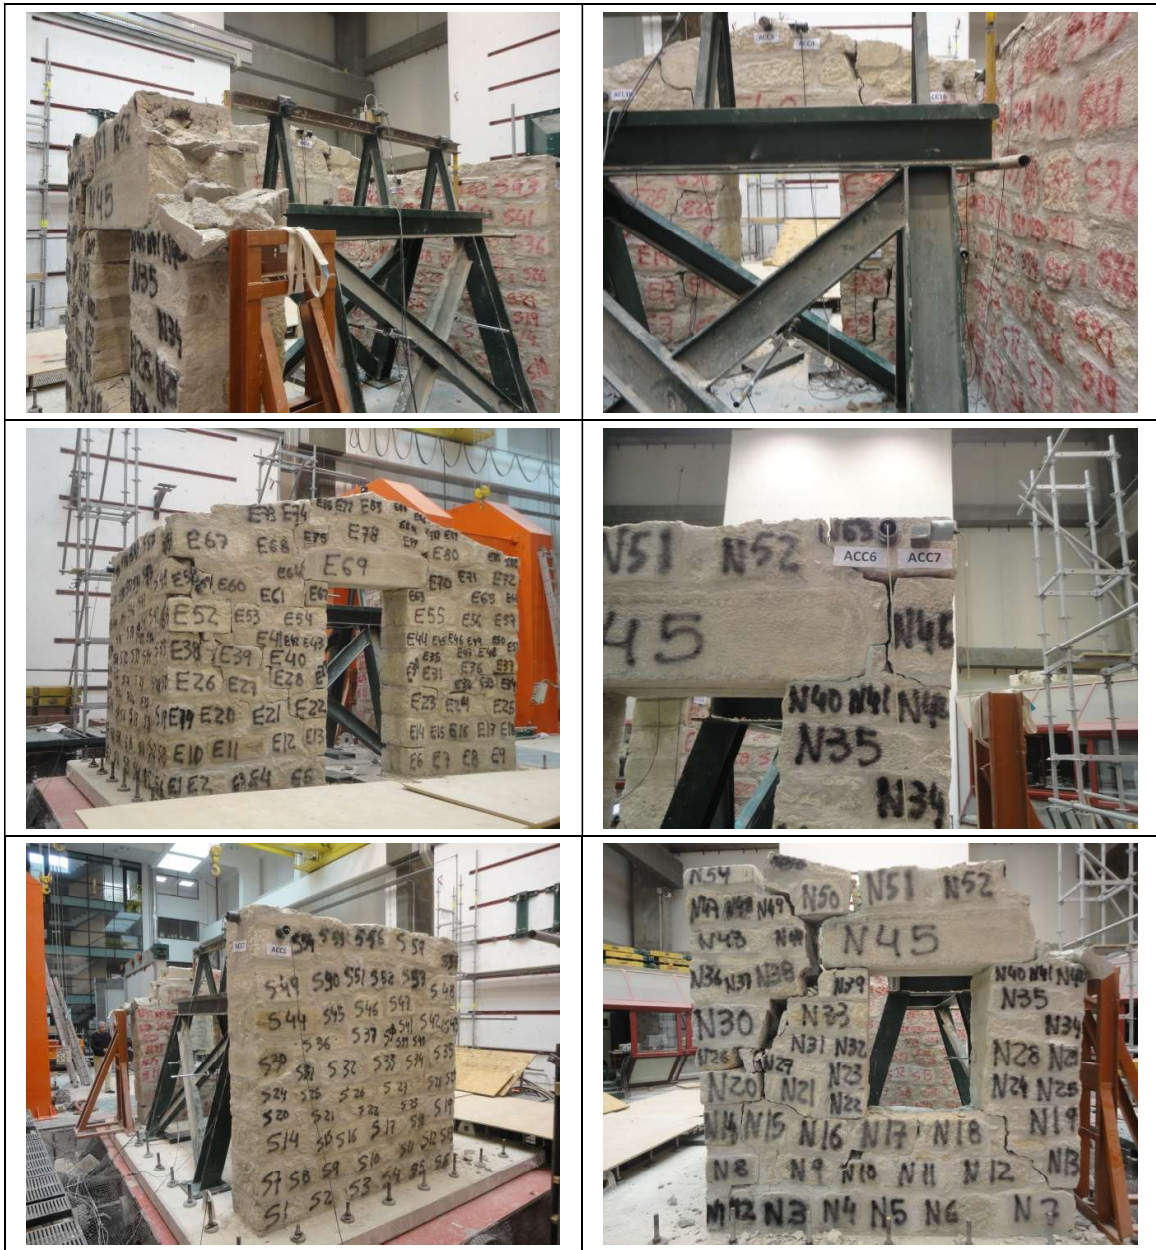
Figure 19 – Final damage state on the Stone House

The Stone House mock-up reached a near collapse condition in TEST05 (1.05g), see Figure 19. Its behaviour was clearly influenced by the presence of the window on the North side and the door in the East façade. The former introduced a weakness in the plane of the North wall where the large dimensions and weight of the lintel stone played an important role in the development of the crack propagation and rocking of the Northeast corner. In the latter, the proportion of the door height relative to the wall height created a discontinuity in the wall dividing it into three parts, North, centre and South.
